# ROBBINS LIBRARY

## EXTERIOR ENVELOPE REPAIRS - PHASE 1A BID NO.19-58

COVER SHEET

BID  
DOCUMENTS

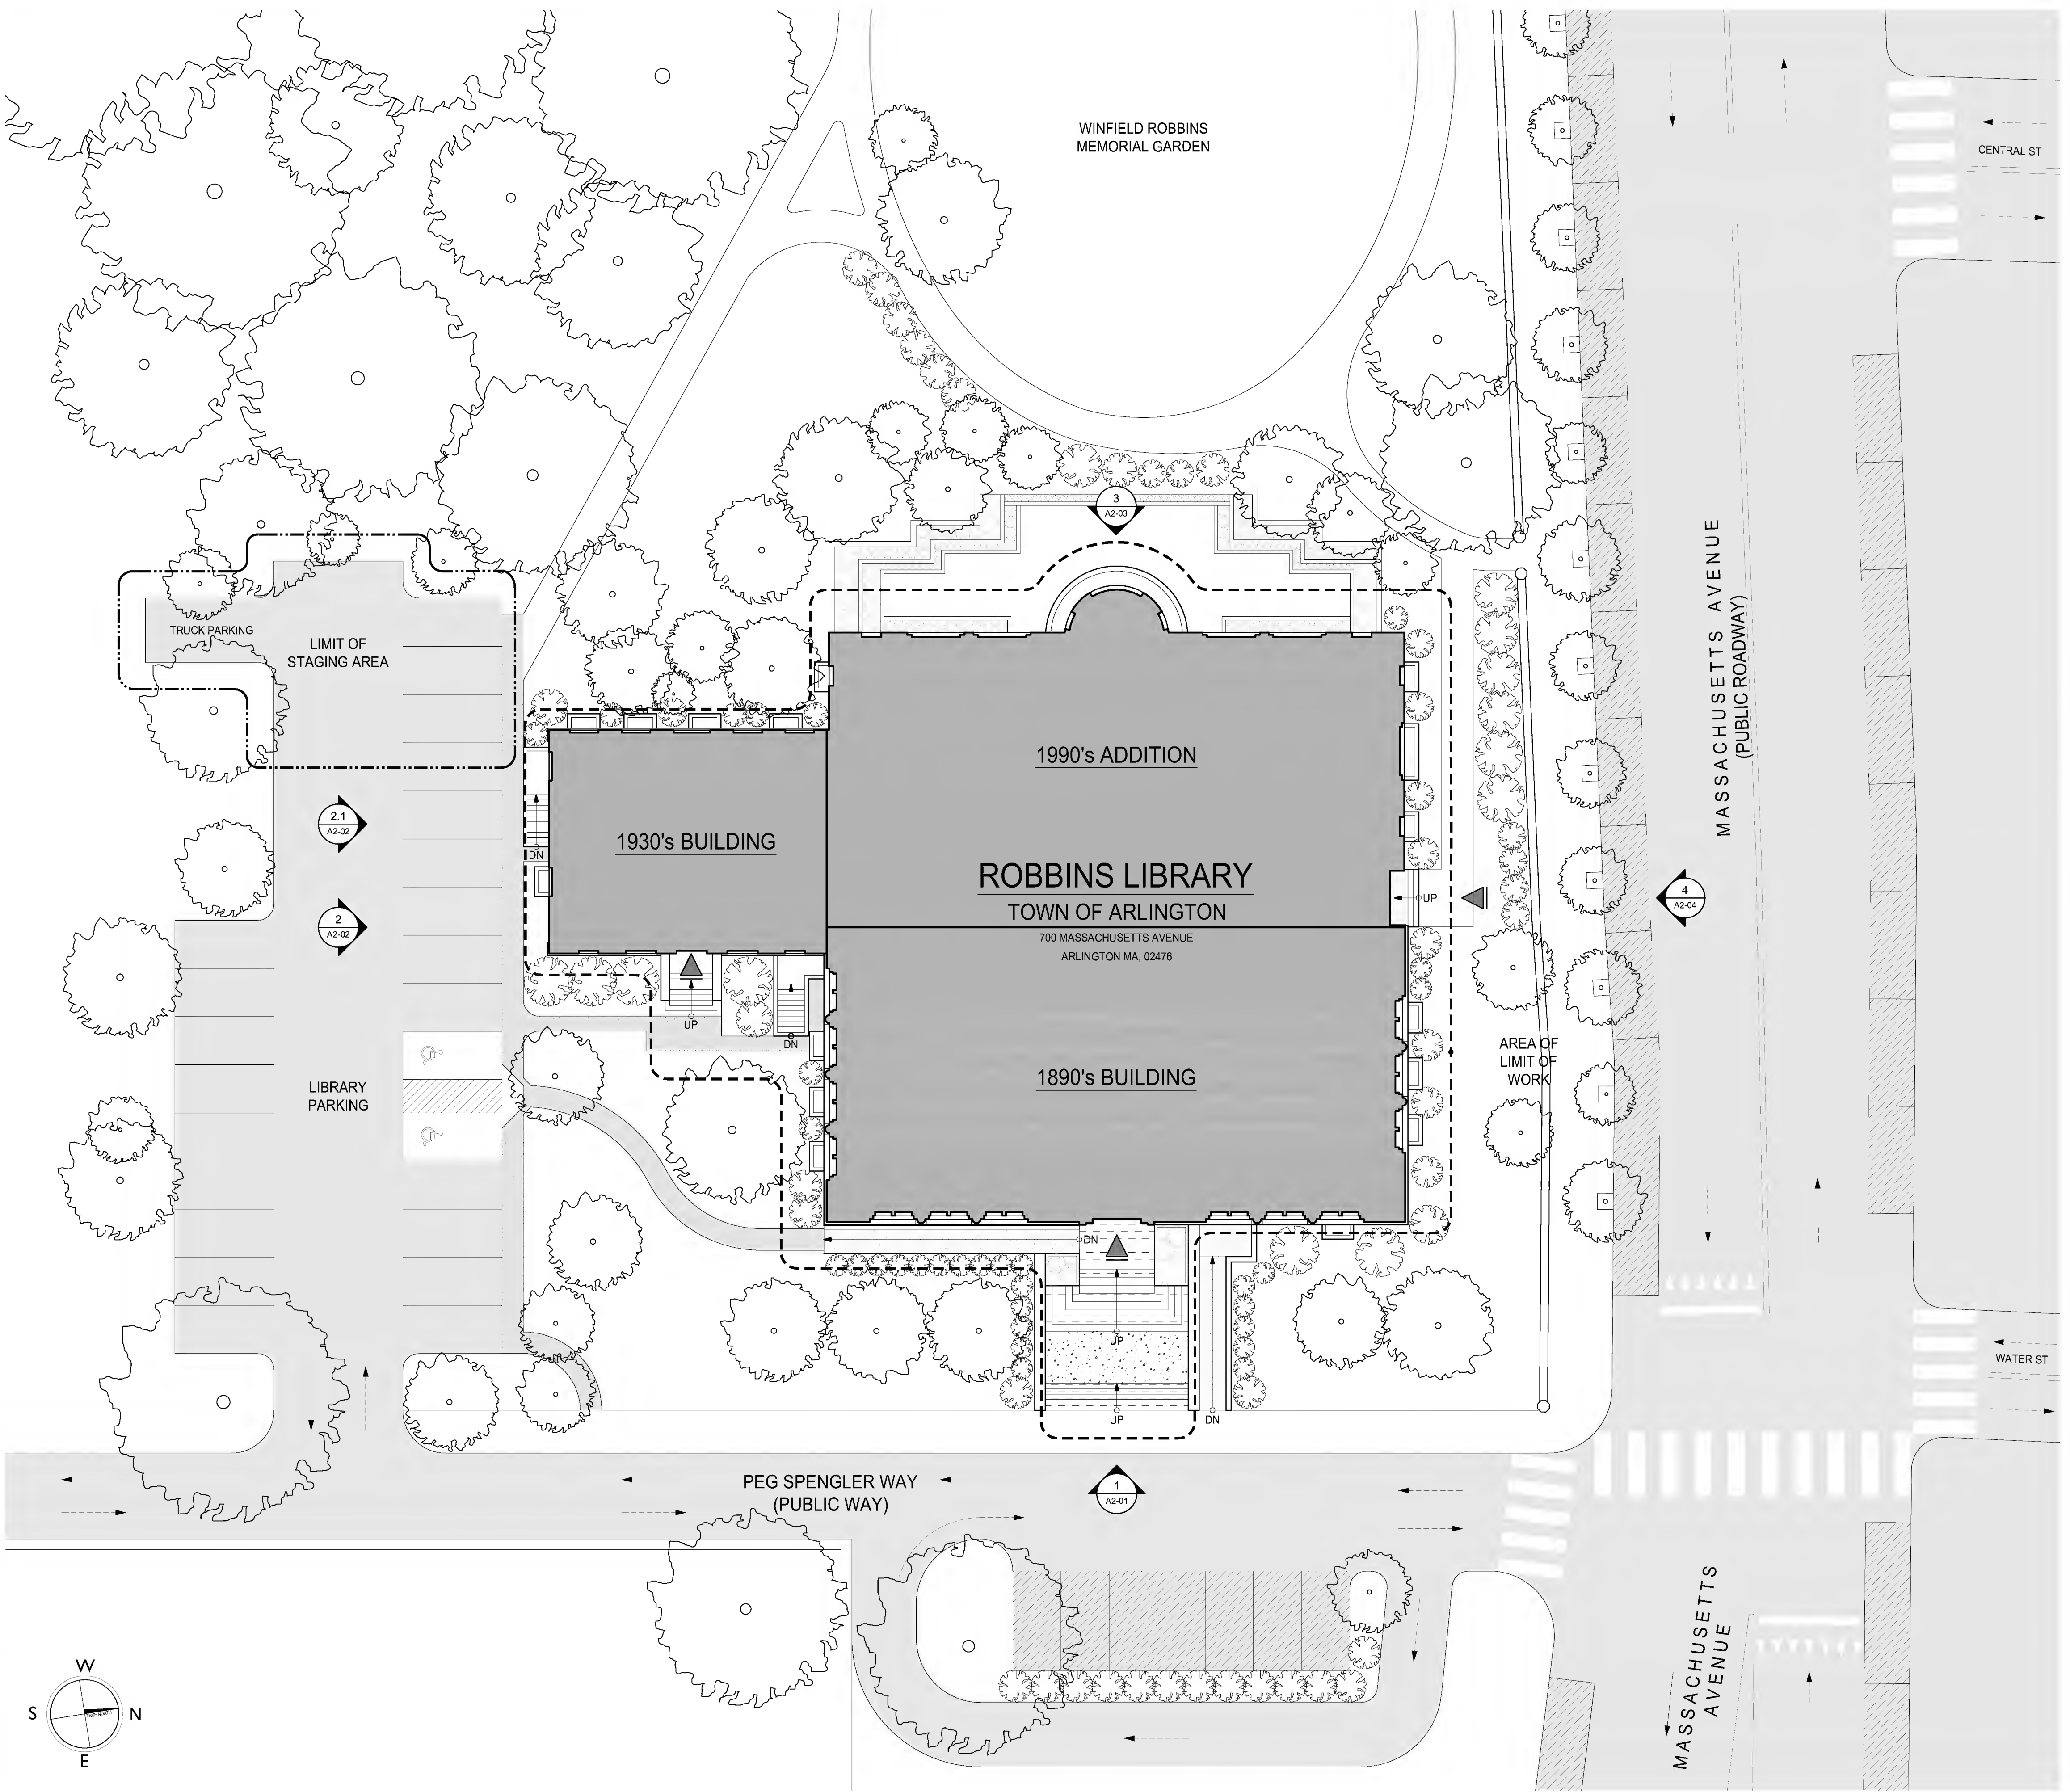
Drawing Title:  
**EXISTING  
SITE PLAN**

- GENERAL SITE NOTES:**
1. PROTECT ALL EXISTING GRASS, SHRUBS AND TREES WITHIN AND IN PROXIMITY TO THE LIMIT OF WORK AREA INCLUDING, CONTRACTOR'S STORAGE, LAY-DOWN AND FENCED AREAS. DO NOT OPERATE MACHINERY UNDERNEATH TREE CANOPIES, TYPICAL. REPAIR OR REPLACE ALL DAMAGED AREAS TO THE SATISFACTION OF THE OWNER.

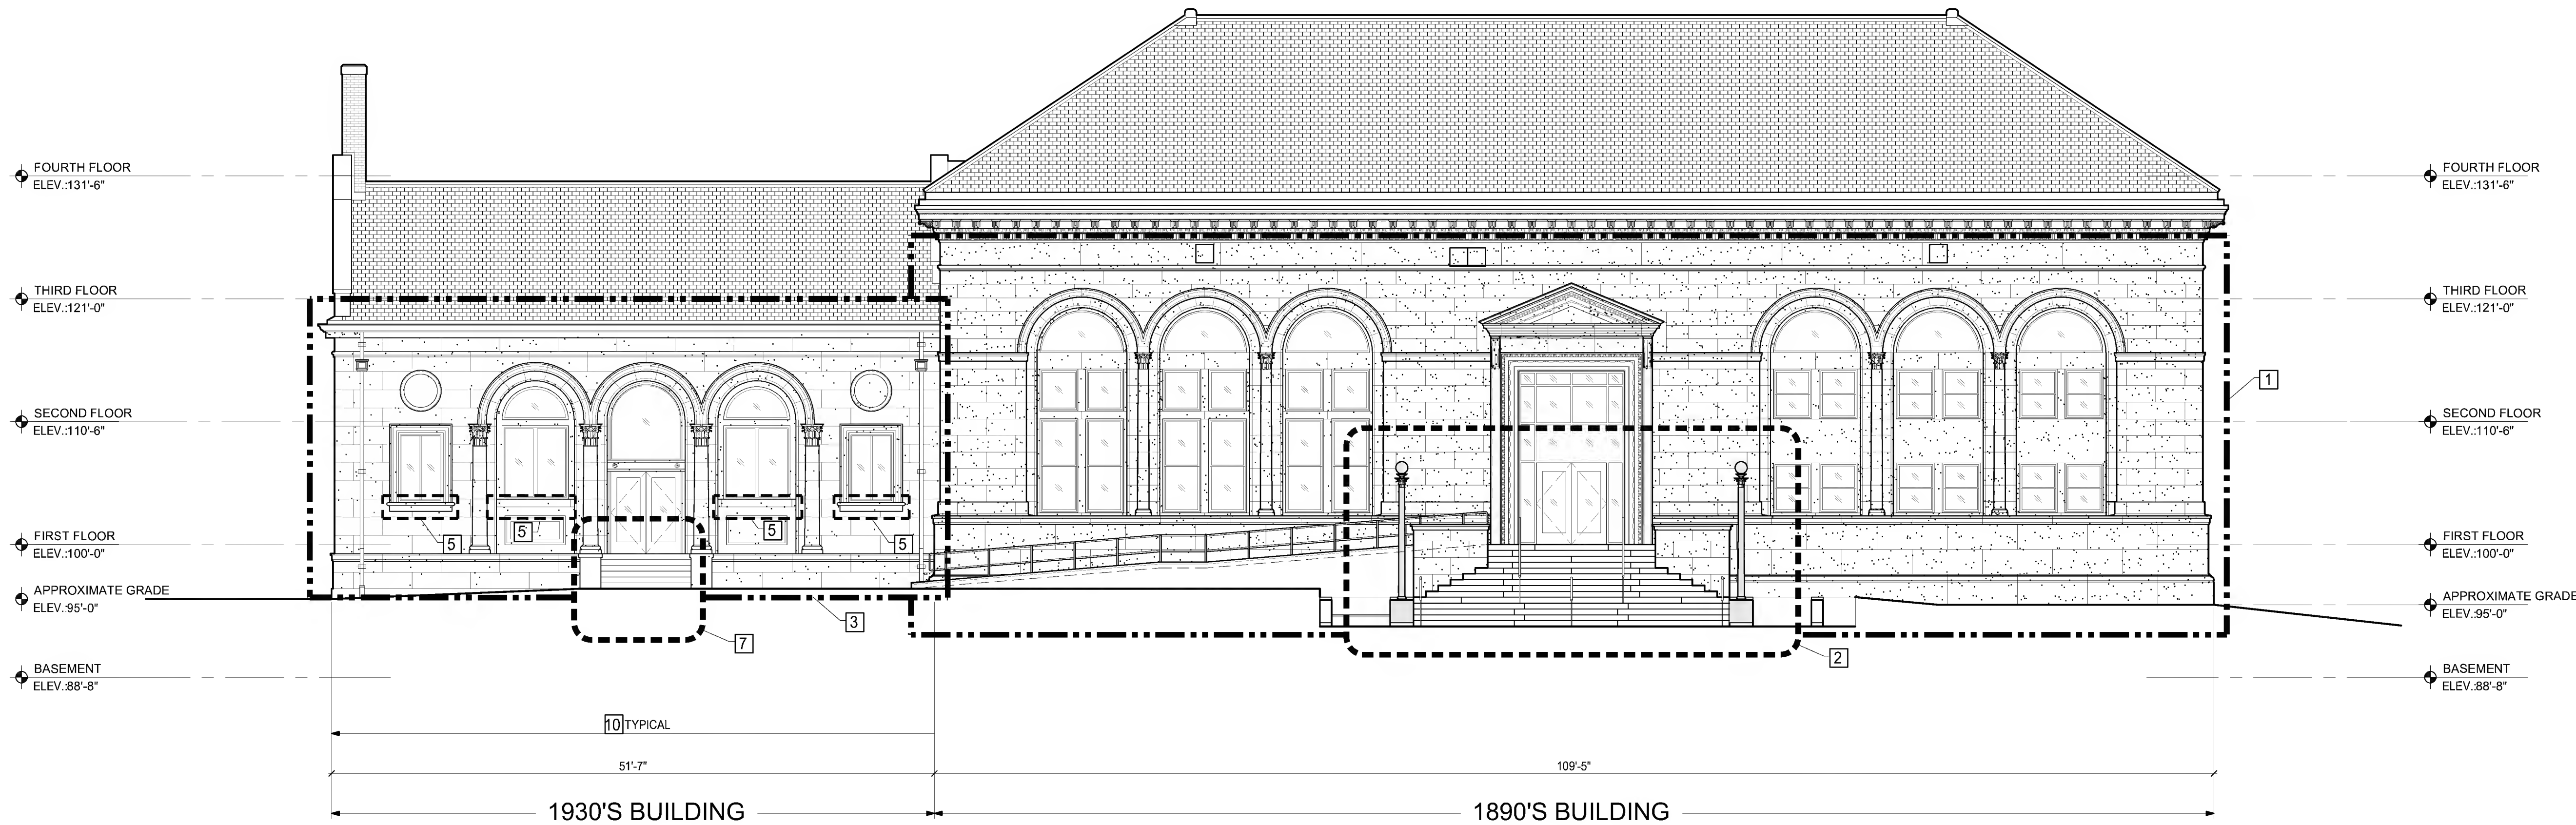
**1 EAST EXTERIOR ELEVATION**  
SCALE: 1/8"=1'-0"

- ROUTE AND CLEAN EXISTING CRACKS IN ANY SANDSTONE (1890'S BUILDING) DETAIL OR ELEMENT, AND FILL CRACKS WITH INJECTION RESTORATION REPAIR MORTAR. TOTAL QUANTITY OF 50 LINEAL FEET IN SELECT AND RANDOM LOCATIONS ACROSS ALL ELEVATIONS AS SELECTED BY ARCHITECT. REFER TO UNIT PRICES - SPECIFICATION 01 22 00.

- REPLACE EXISTING SEALANT AND MORTAR JOINTS OF THE EXTERIOR GRANITE STONE STAIRS AT MAIN ENTRANCE OF THE 1890'S LIBRARY BUILDING. CUT, REMOVE AND DISPOSE OF 100% ALL EXISTING VERTICAL AND HORIZONTAL JOINT SEALANTS, INCLUDING UNDERLYING MORTAR A MINIMUM OF 1-1/2-INCHES OR UNTIL SOUND MORTAR FROM ALL GRANITE STONE STAIRS. APPLY NEW POINTING MORTAR TO WITHIN 1/2-INCH OF THE SURFACE AND APPLY POLYURETHANE SEALANT TO ALL GRANITE STONE JOINTS. STAIRS SHALL BE POWER WASHED CLEANED. SEE ENLARGE PLAN 1/ A401 AND DETAIL 5a & 5b / A4-01.

- ROUTE AND CLEAN EXISTING CRACKS IN ANY ARCHITECTURAL CAST STONE ( 1930S BUILDING ) DETAIL OR ELEMENT, AND FILL CRACKS WITH INJECTION RESTORATION REPAIR MORTAR. TOTAL QUANTITY OF 25 LINEAL FEET IN SELECT AND RANDOM LOCATIONS ACROSS ALL ELEVATION SELECTED BY THE ARCHITECT. SEE DETAIL 1a & 1b/ A4-01. REFER TO UNIT PRICE - SPECIFICATION 01 22 00.

- CUT OUT AND DISPOSE SPALLS, CHIPS AND DELAMINATIONS IN THE ARCHITECTURAL CAST STONE WINDOW SILL. CUT OUT A MINIMUM 1/2" DEEP & SQUARE OFF ALL EDGES. CLEAN SURFACE & APPLY SINGLE COMPONENT, CEMENTITIOUS MINERAL BASED REPAIR MORTAR TOTAL QUANTITY OF 208 CUBIC INCHES IN SELECT AND RANDOM LOCATIONS ACROSS ALL ELEVATION SELECTED BY THE ARCHITECT. REFER TO UNIT PRICE - SPECIFICATION 01 22 00.

- APPLY NEW BACKER ROD WHERE GASKETS ARE MISSING BETWEEN THE PANEL AND FRAME.
    - CLEAN AND PRIME SURFACES AND APPLY NON-SAG SINGLE COMPONENT SILICONE SEALANT. COLOR TO BE SELECTED BY ARCHITECT FROM FULL RANGE OF CUSTOM COLORS.

- REFER TO DEDUCT ALTERNATE NO. 2.
  - CUT OUT AND DISPOSE SPALLS, CHIPS AND DELAMINATION IN THE ARCHITECTURAL CAST IN PLACE STONE EXIT STAIRS OF THE 1930'S BUILDING. CUT OUT A MINIMUM 1" DEEP & SQUARE OFF ALL EDGES. CLEAN SURFACE & APPLY SINGLE COMPONENT, CEMENTITIOUS MINERAL BASED REPAIR MORTAR.

- REPLACE EXISTING SEALANT AND MORTAR JOINTS AT THE EXIT STAIRS OF THE 1930'S BUILDING. CUT, REMOVE AND DISPOSE OF 100% ALL EXISTING VERTICAL AND HORIZONTAL JOINT SEALANTS, INCLUDING UNDERLYING MORTAR A MINIMUM OF 1-1/2-INCHES OR UNTIL SOUND MORTAR FROM ALL ARCHITECTURAL CAST IN PLACE STONE STAIRS AND LANDING. APPLY NEW POINTING MORTAR TO WITHIN 1/2-INCH OF THE SURFACE AND APPLY POLYURETHANE SEALANT TO ALL CAST IN PLACE STONE STAIRS AND LANDING JOINTS. STAIRS SHALL BE POWER WASHED CLEANED. SEE DETAIL 3 & 4 / A4-01.

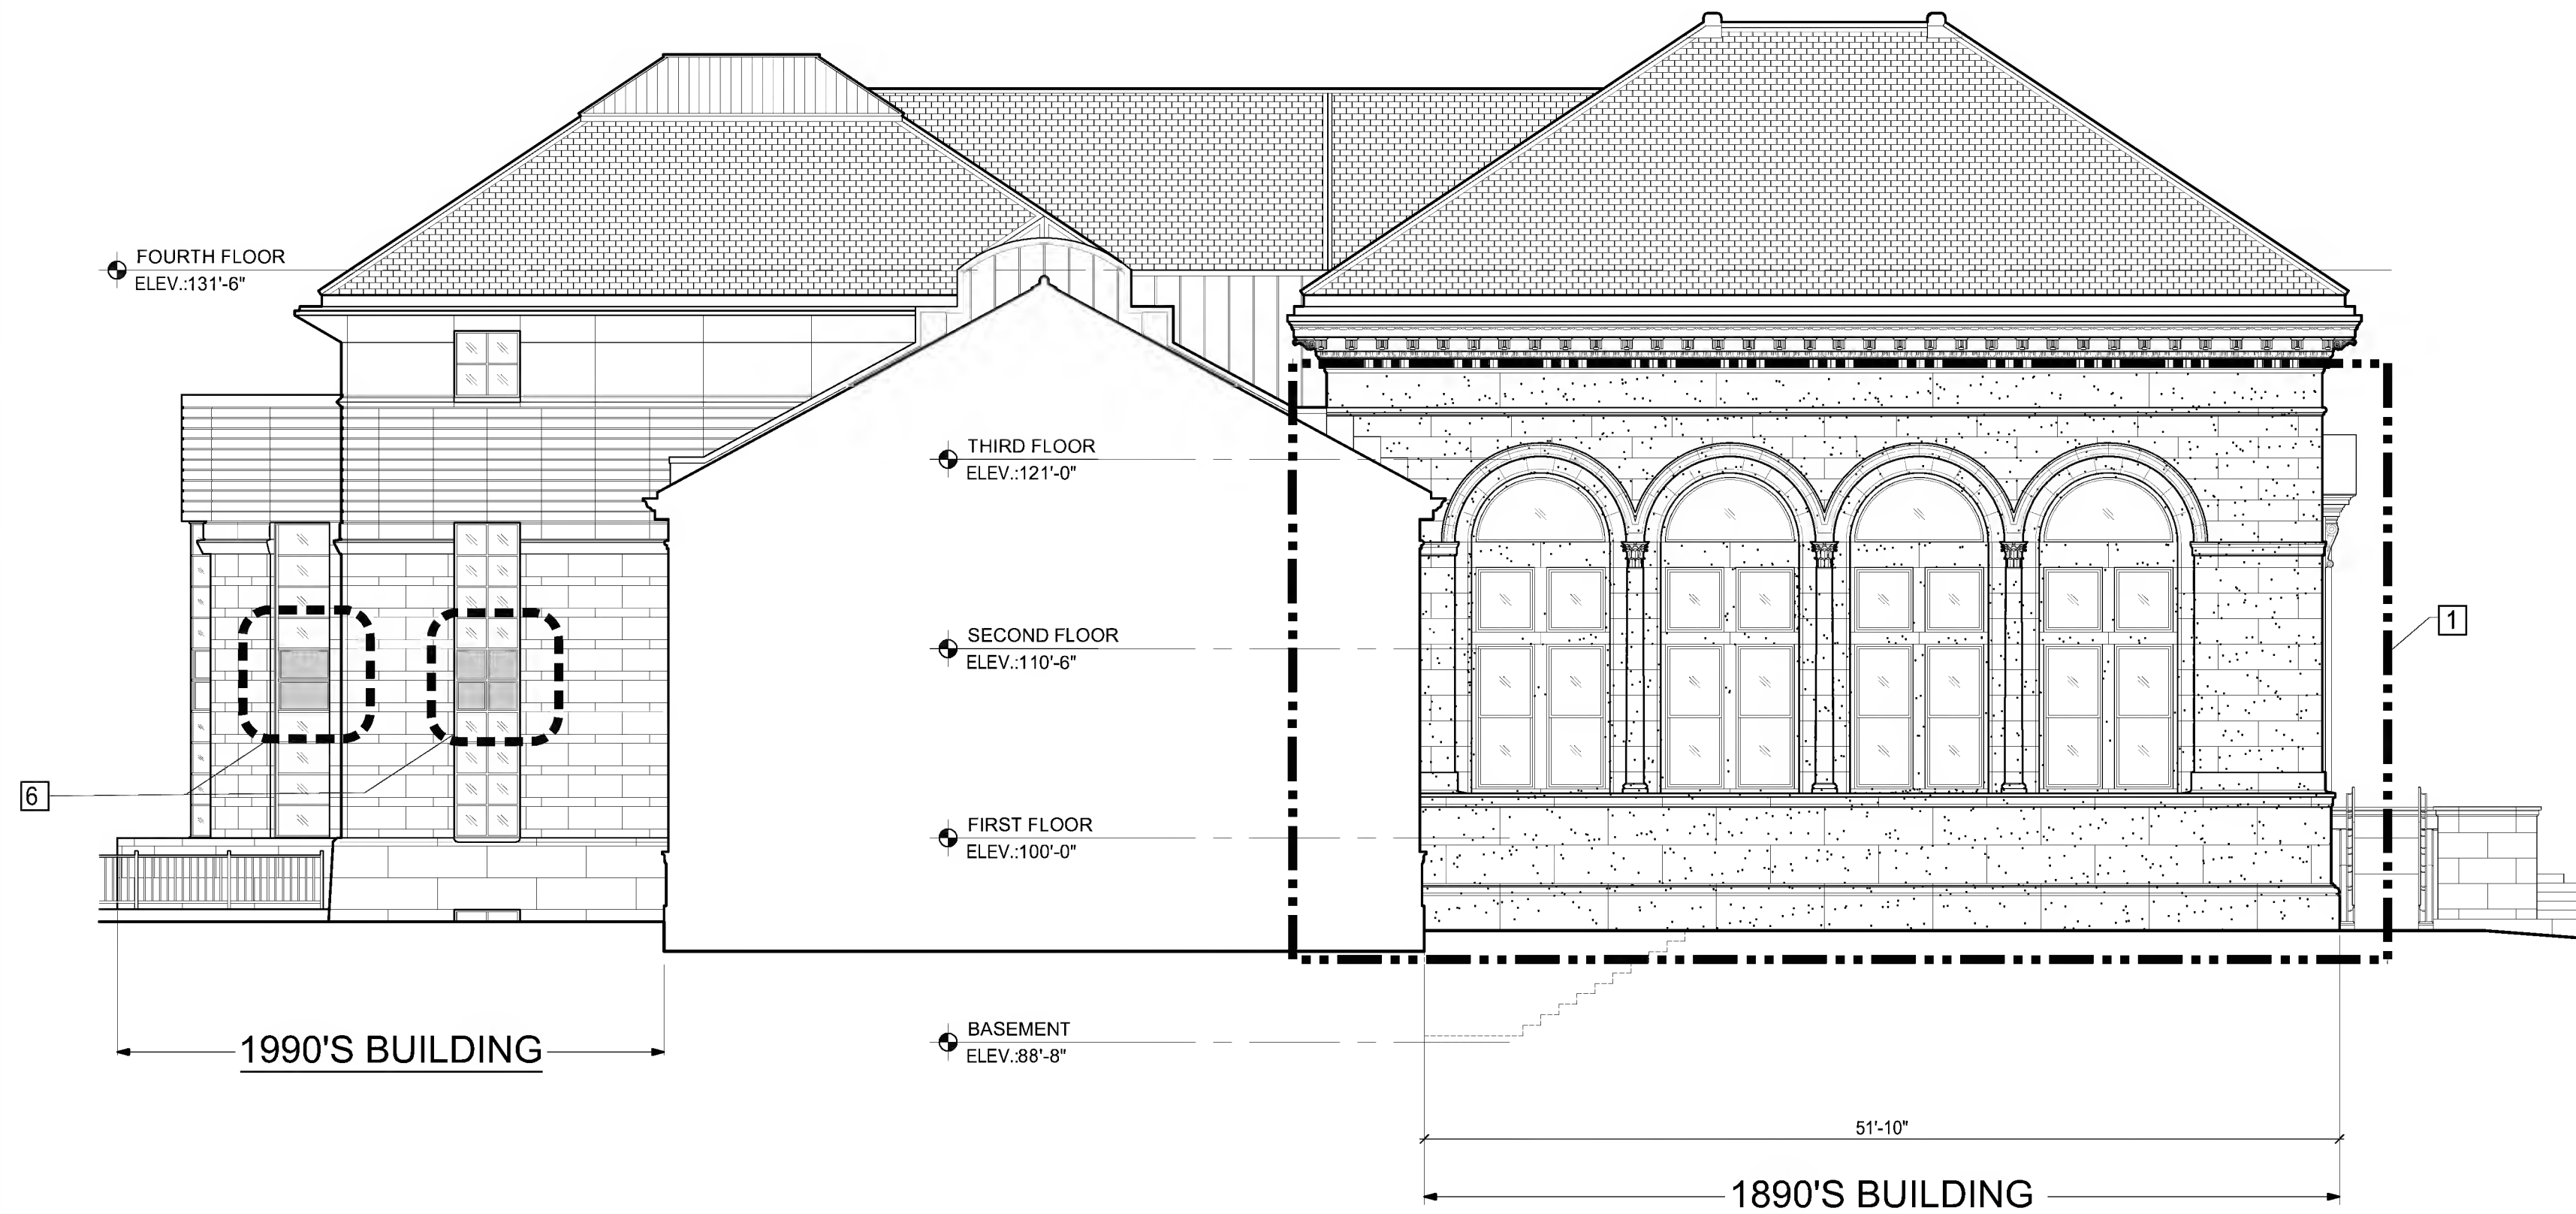
**2 SOUTH EXTERIOR ELEVATION**  
SCALE: 1/8"=1'-0"

- 1.** ROUTE AND CLEAN EXISTING CRACKS IN ANY SANDSTONE (1890'S BUILDING) DETAIL OR ELEMENT, AND FILL CRACKS WITH INJECTION RESTORATION REPAIR MORTAR. TOTAL QUANTITY OF 50 LINEAL FEET IN SELECT AND RANDOM LOCATIONS ACROSS ALL ELEVATIONS AS SELECTED BY ARCHITECT. REFER TO UNIT PRICES - SPECIFICATION 01 22 00.

- 2.** REPLACE EXISTING SEALANT AND MORTAR JOINTS OF THE EXTERIOR GRANITE STONE STAIRS AT MAIN ENTRANCE OF THE 1890'S LIBRARY BUILDING. CUT, REMOVE AND DISPOSE OF 100% ALL EXISTING VERTICAL AND HORIZONTAL JOINT SEALANTS, INCLUDING UNDERLYING MORTAR A MINIMUM OF 1-1/2-INCHES OR UNTIL SOUND MORTAR FROM ALL GRANITE STONE STAIRS. APPLY NEW POINTING MORTAR TO WITHIN 1/2-INCH OF THE SURFACE AND APPLY POLYURETHANE SEALANT TO ALL GRANITE STONE JOINTS. STAIRS SHALL BE POWER WASHED CLEANED. SEE ENLARGE PLAN 1/A401 AND DETAIL 5a & 5b / A4-01.

- 3.** ROUTE AND CLEAN EXISTING CRACKS IN ANY ARCHITECTURAL CAST STONE ( 1930S BUILDING ) DETAIL OR ELEMENT, AND FILL CRACKS WITH INJECTION RESTORATION REPAIR MORTAR. TOTAL QUANTITY OF 25 LINEAL FEET IN SELECT AND RANDOM LOCATIONS ACROSS ALL ELEVATION SELECTED BY THE ARCHITECT. SEE DETAIL 1a & 1b / A4-01. REFER TO UNIT PRICE - SPECIFICATION 01 22 00.

- 5.** CUT OUT AND DISPOSE SPALLS, CHIPS AND DELAMINATIONS IN THE ARCHITECTURAL CAST STONE WINDOW SILL. CUT OUT A MINIMUM 1/2" DEEP & SQUARE OFF ALL EDGES. CLEAN SURFACE & APPLY SINGLE COMPONENT, CEMENTITIOUS MINERAL BASED REPAIR MORTAR TOTAL QUANTITY OF 208 CUBIC INCHES IN SELECT AND RANDOM LOCATIONS ACROSS ALL ELEVATION SELECTED BY THE ARCHITECT. REFER TO UNIT PRICE - SPECIFICATION 01 22 00.

- b. APPLY NEW BACKER ROD WHERE GASKETS ARE MISSING BETWEEN THE PANEL AND FRAME.
    - c. CLEAN AND PRIME SURFACES AND APPLY NON-SAG SINGLE COMPONENT SILICONE SEALANT. COLOR TO BE SELECTED BY ARCHITECT FROM FULL RANGE OF CUSTOM COLORS.

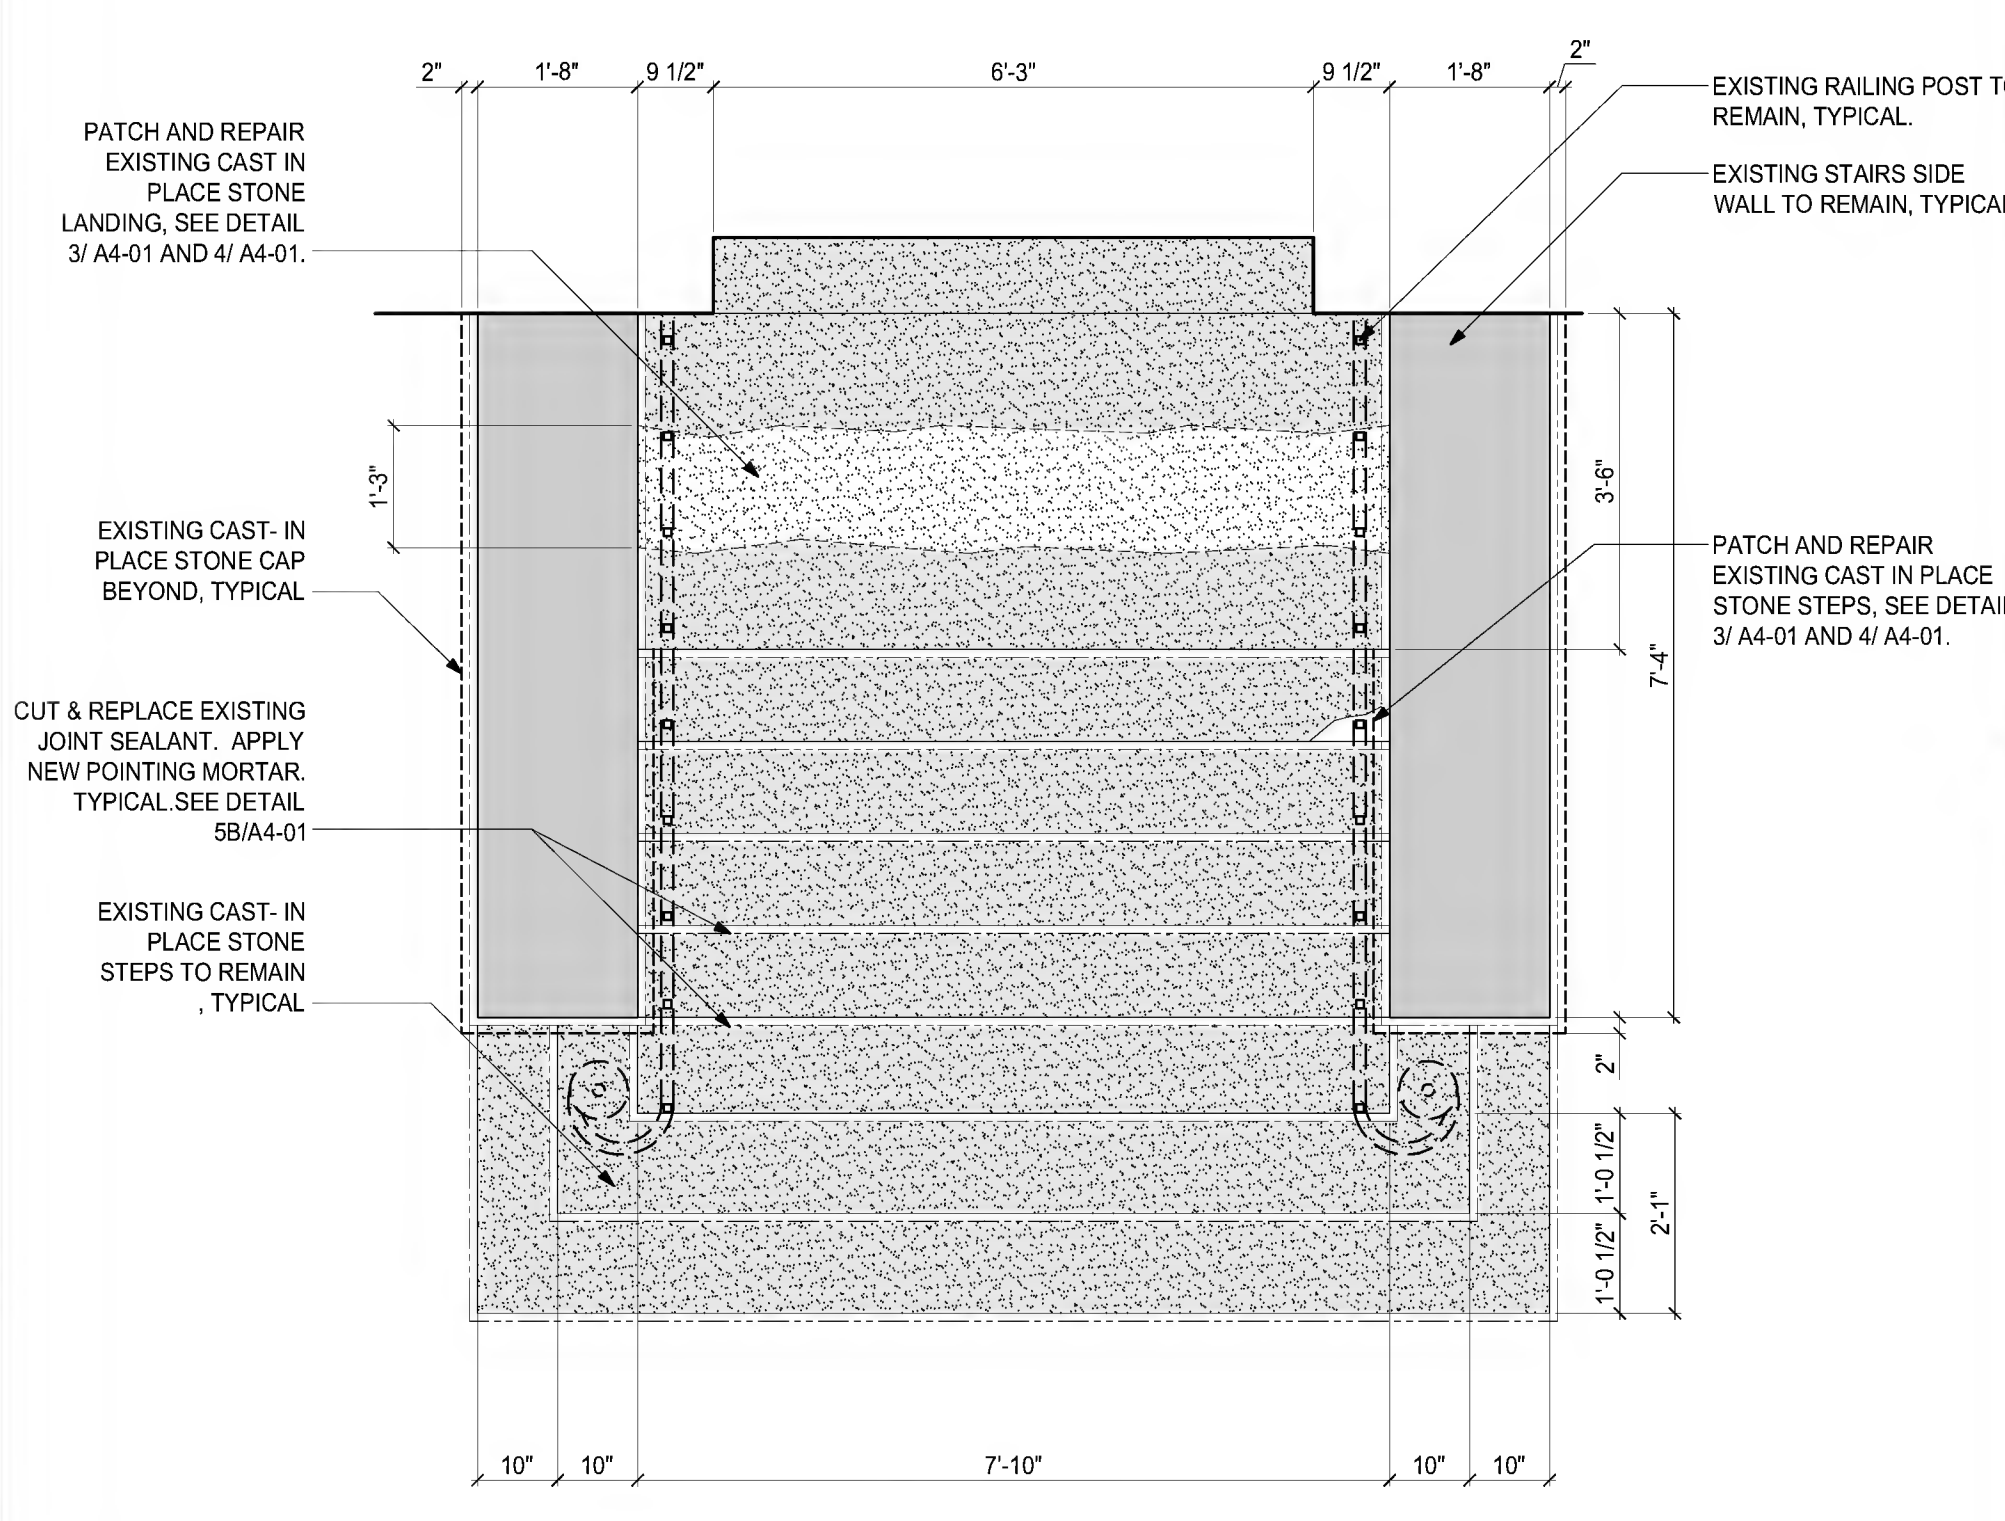
1 1930'S BUILDING  
EXIT STAIRS REPAIR PLAN  
SCALE: 1/2"=1'-0"

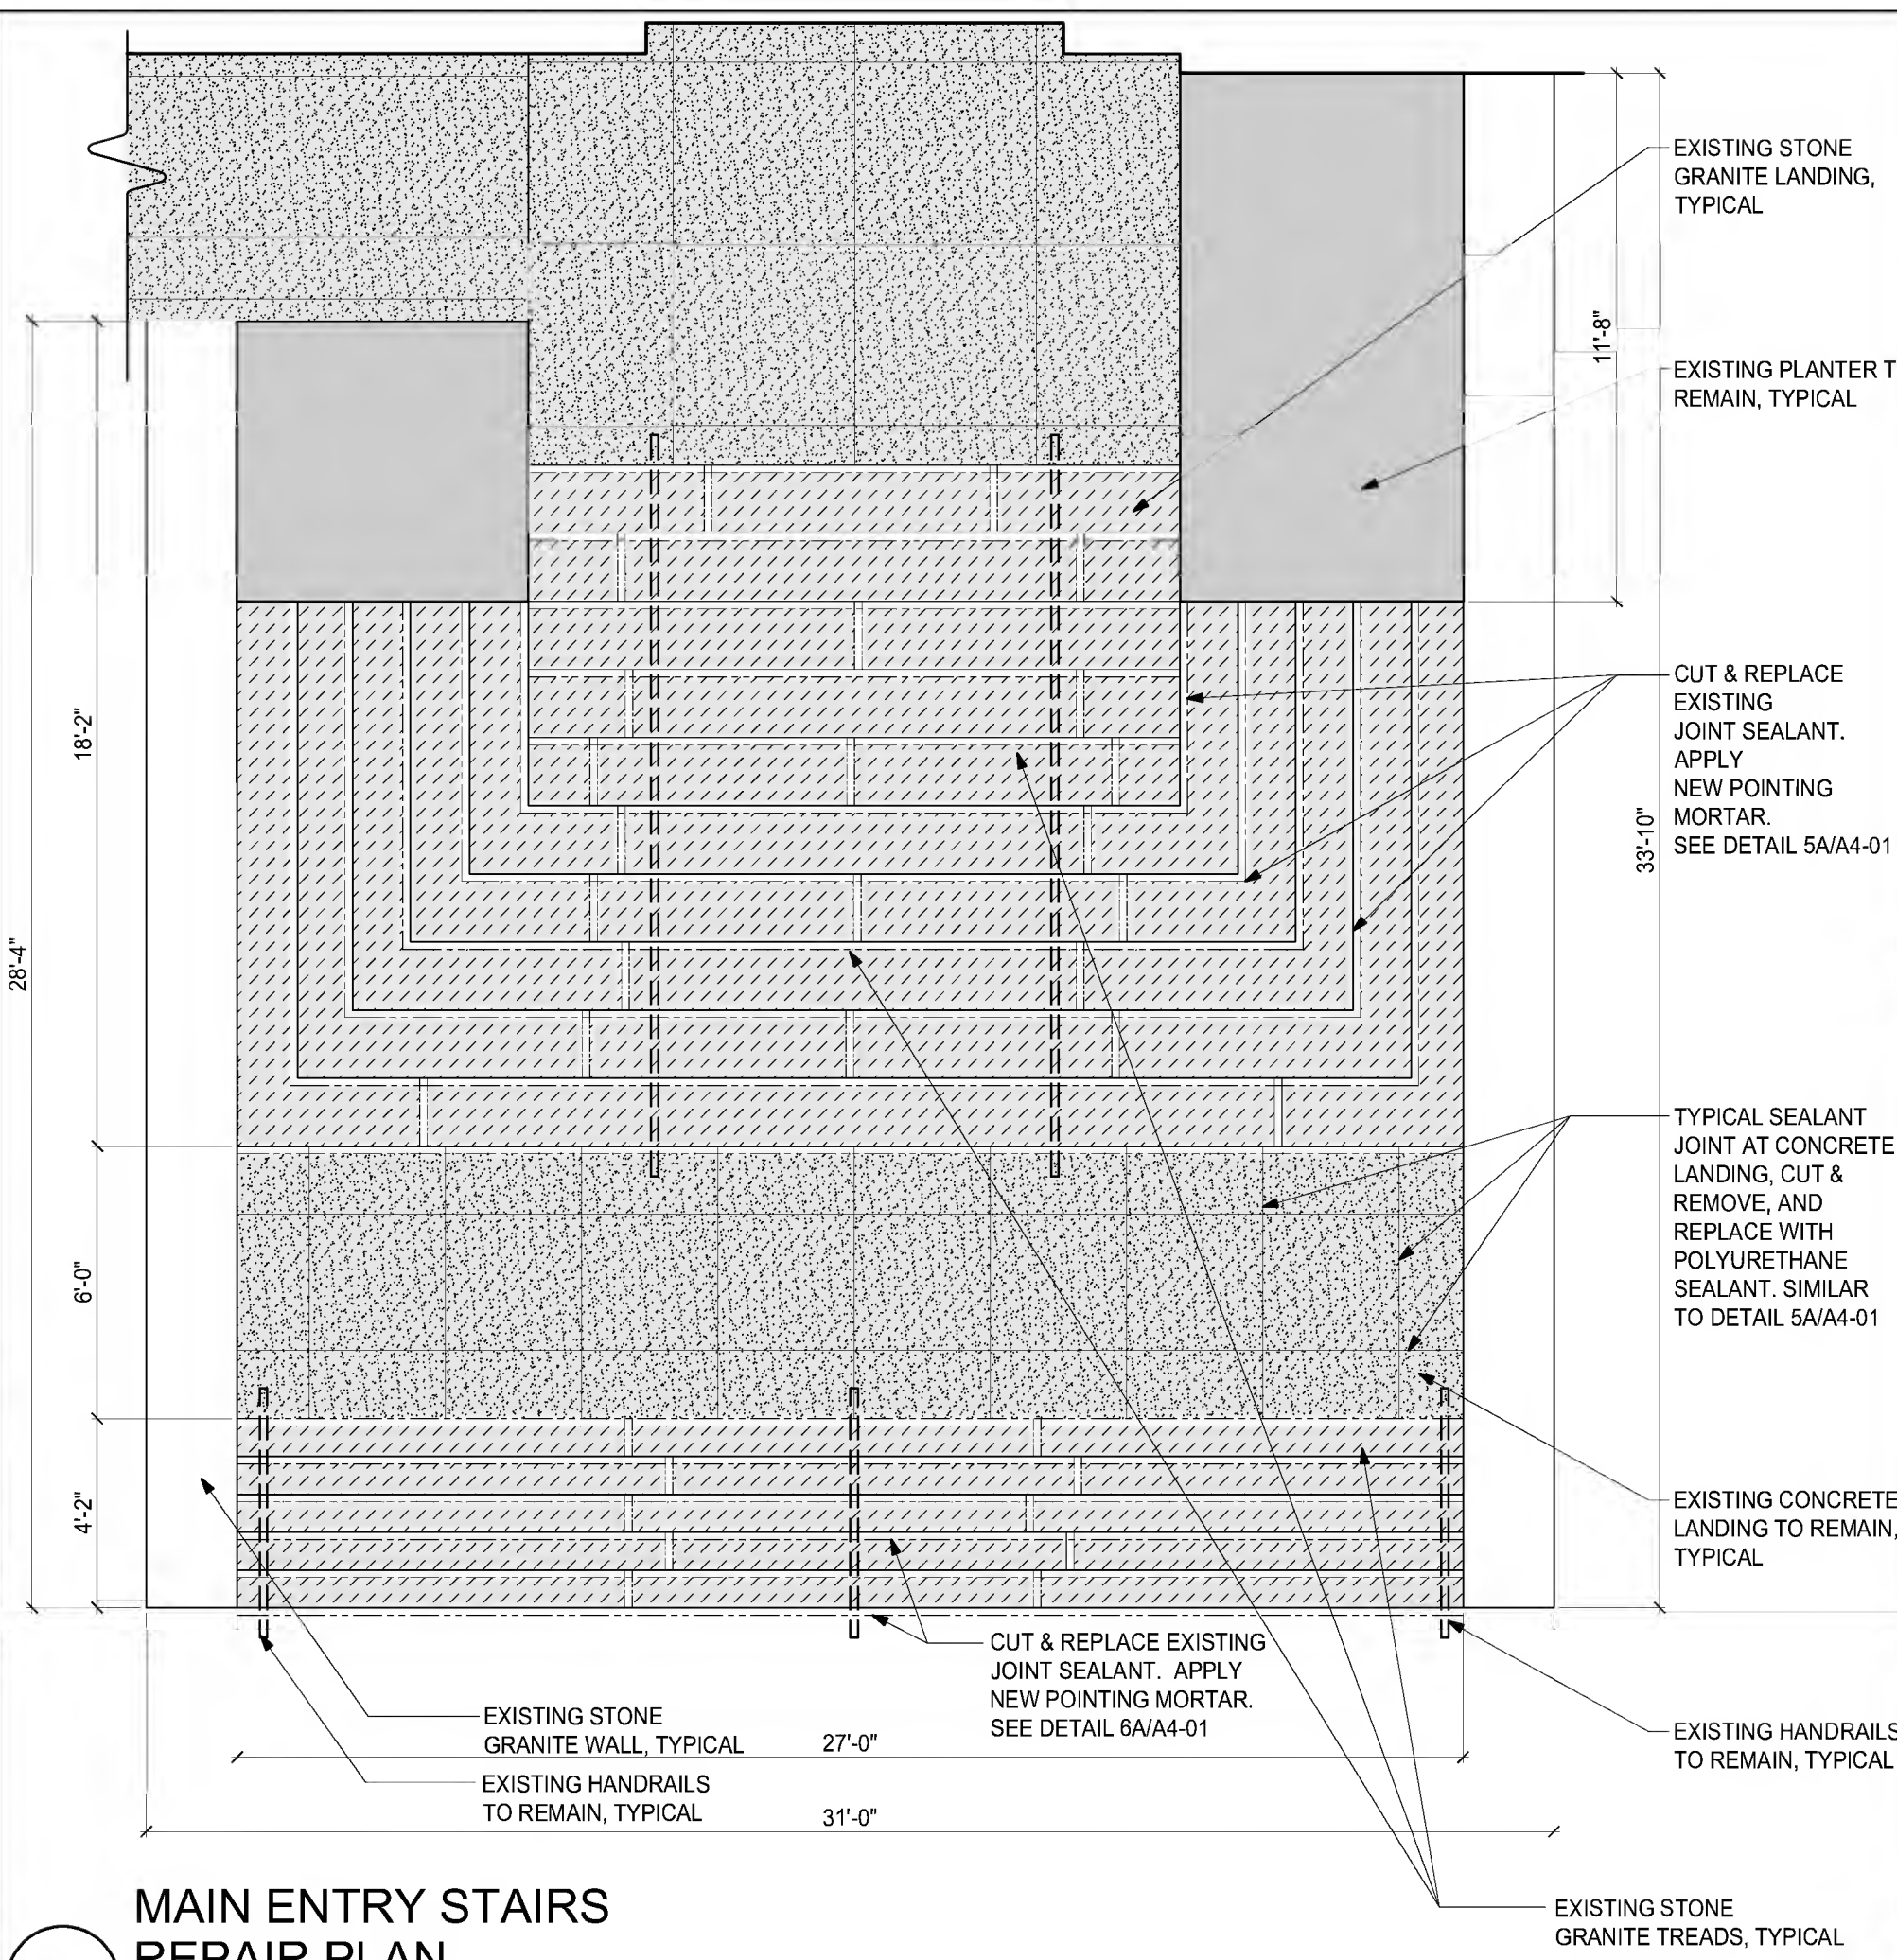
2 MAIN ENTRY STAIRS  
REPAIR PLAN  
SCALE: 1/4"=1'-0"

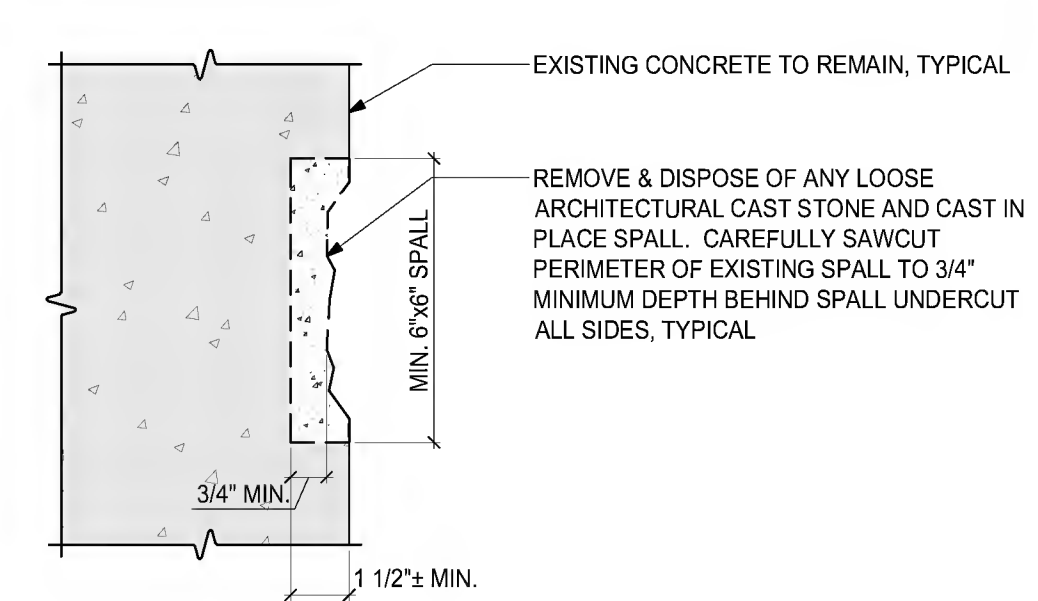
3 TYPICAL ARCHITECTURAL CAST STONE  
SPALL REPAIR DEMOLITION DETAIL  
SCALE: 3"=1'-0"

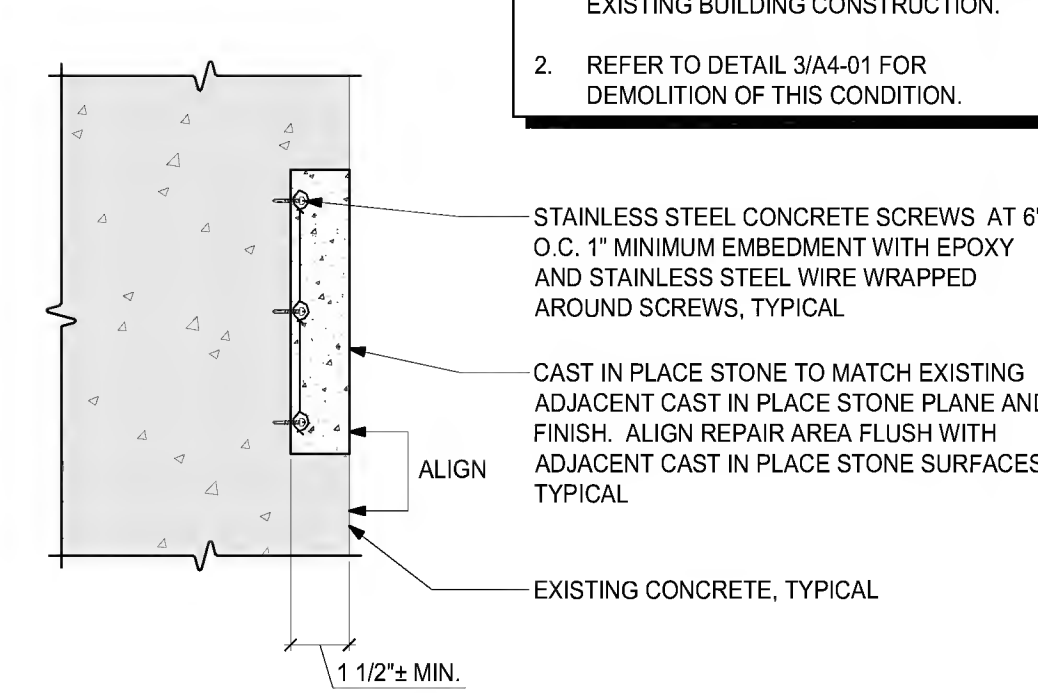
4 TYPICAL ARCHITECTURAL CAST STONE  
SPALL REPAIR DETAIL  
SCALE: 3"=1'-0"

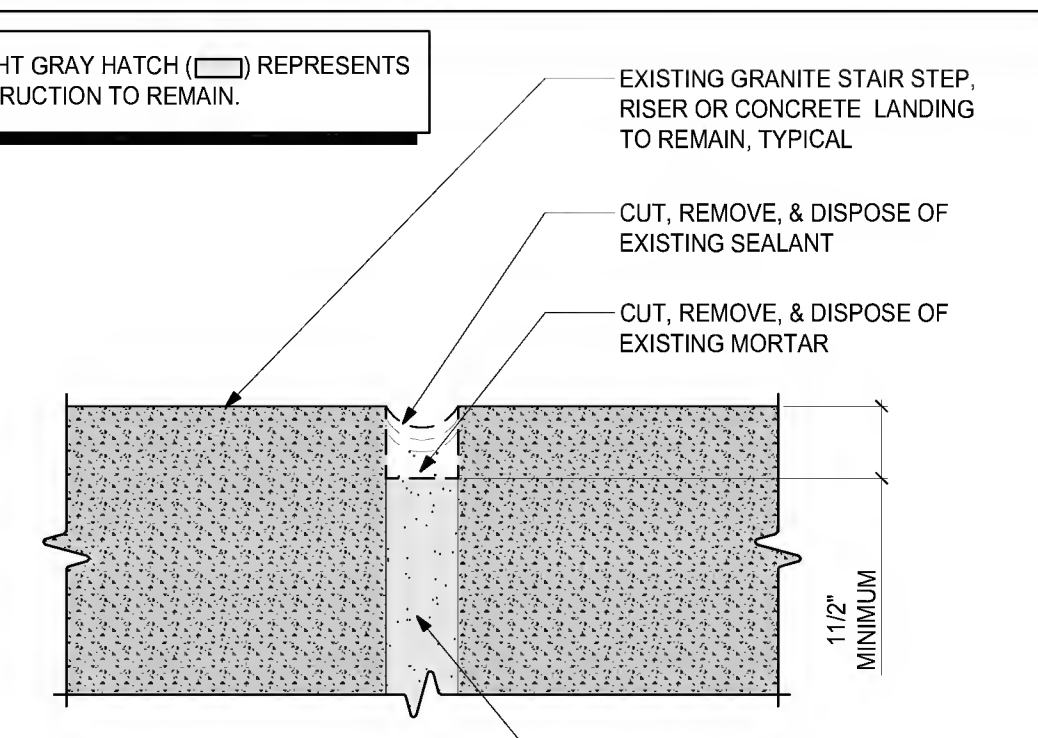
5A TYPICAL POINTING DEMOLITION OF  
GRANITE AND CAST IN PLACE  
STONE STAIR JOINT DETAIL  
SCALE: 3"=1'-0"

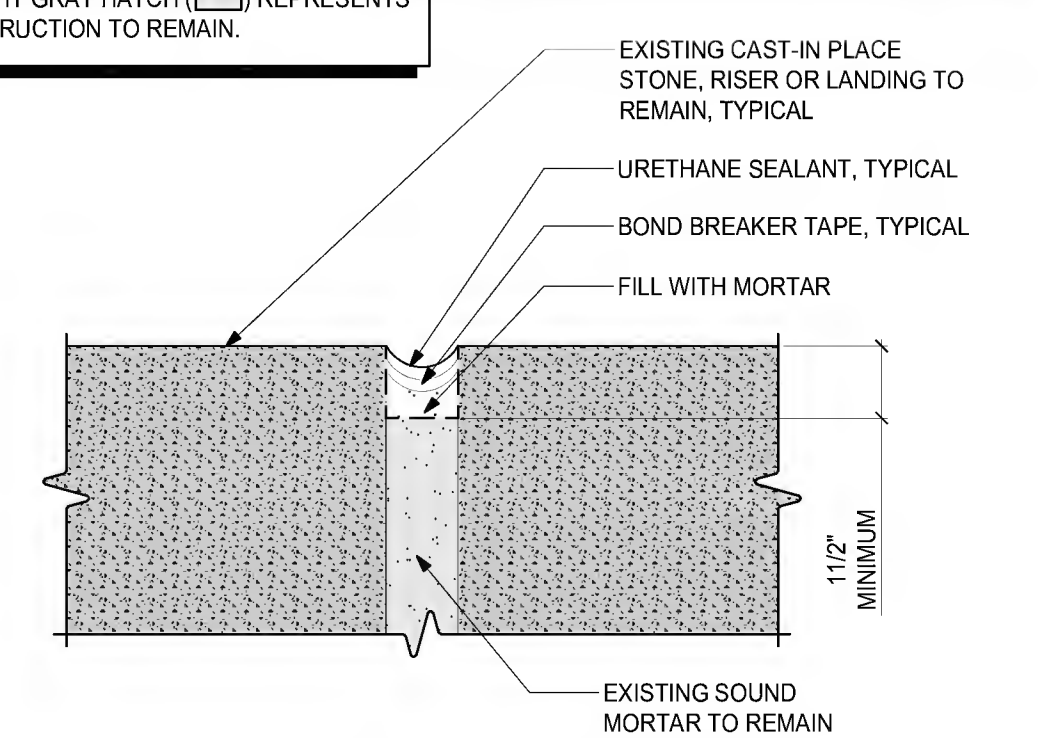
5B TYPICAL POINTING OF CAST IN  
PLACE AND GRANITE STONE  
JOINT DETAIL  
SCALE: 3"=1'-0"

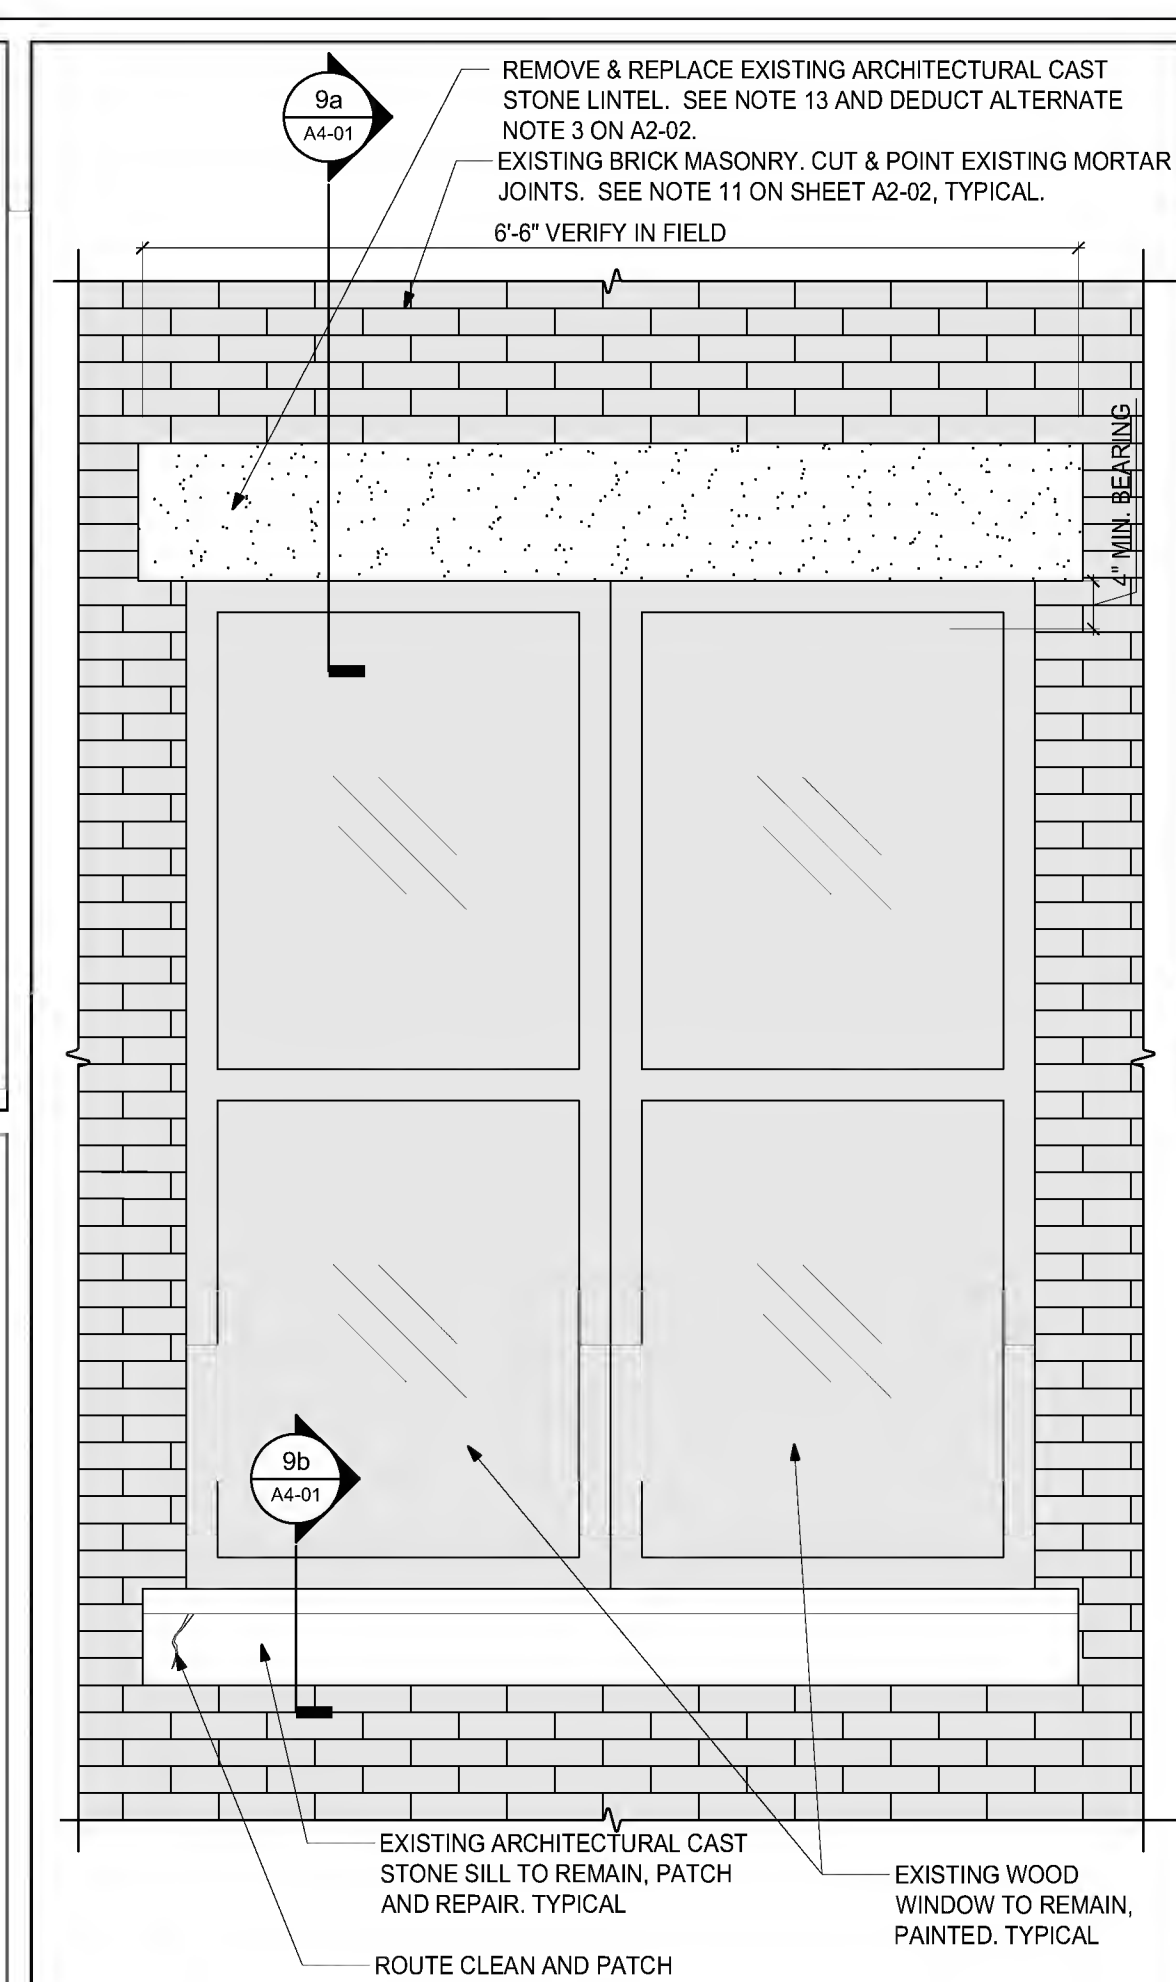
6 ARCHITECTURAL CAST STONE  
LINTEL ENLARGED ELEVATION  
SCALE: 3/4"=1'-0"
